ASSESSMENT OF DAM SAFETY OF COAL COMBUSTION SURFACE IMPOUNDMENTS – FINAL REPORT

**FirstEnergy Corp
Albright Power Station
Albright, West Virginia**

Prepared for
*U.S. Environmental
Protection Agency
Washington, D.C.*

December 2013
Revised April 2014

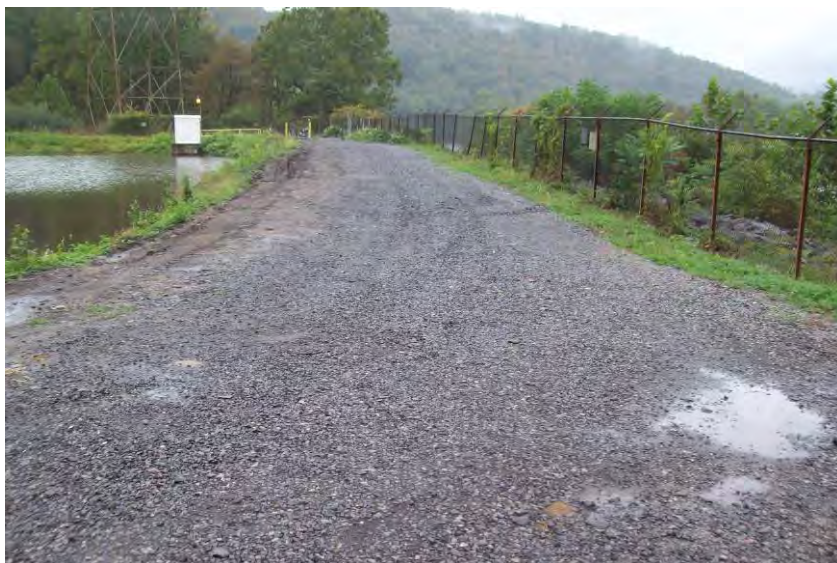
The crest of the North Lagoon's north and east embankments appeared to be in satisfactory condition (Photographs 1, 9, 18 and 24). The 20- to 25-ft-wide crest of the embankment consists of compacted granular soils and gravel and is exposed to minimal vehicle traffic. No depressions or evidence of settlement were observed on the crest. The western side of the North Lagoon was constructed by excavating into the existing hillside and the southern side is incised.

Photo 1: East embankment crest, looking northwest.

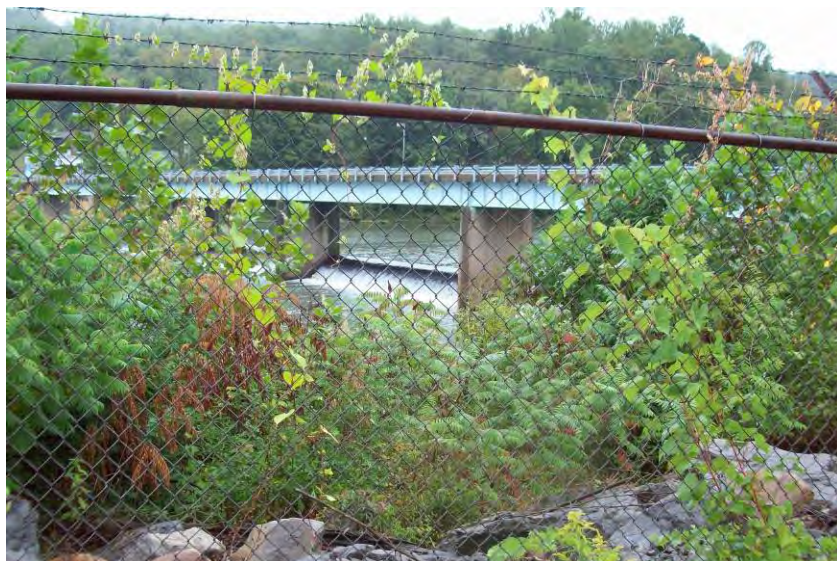
The lagoon includes exterior slopes on the north and east embankments that range from approximately 1H:1V to 3H:1V. The south and west sides of the North Lagoon do not include an exterior slope; the western side of the lagoon was constructed by excavating into the existing hillside and the southern side is incised. Due to the terrain and perimeter fencing around the North Lagoon, the north and east exterior slopes were only visible from the embankment crests. Based on limited observations from the crest, the exterior slopes appear to be in satisfactory condition. The exterior slopes of the North Lagoon embankments are protected with riprap armor. Some minor brush was growing between the riprap (Photographs 5, 8, 10, 15, and 27). The Cheat River is at the east embankment's exterior toe (Photograph 3, 4, and 27).

Photo 3: Cheat River dam beneath bridge into Albright Power Station

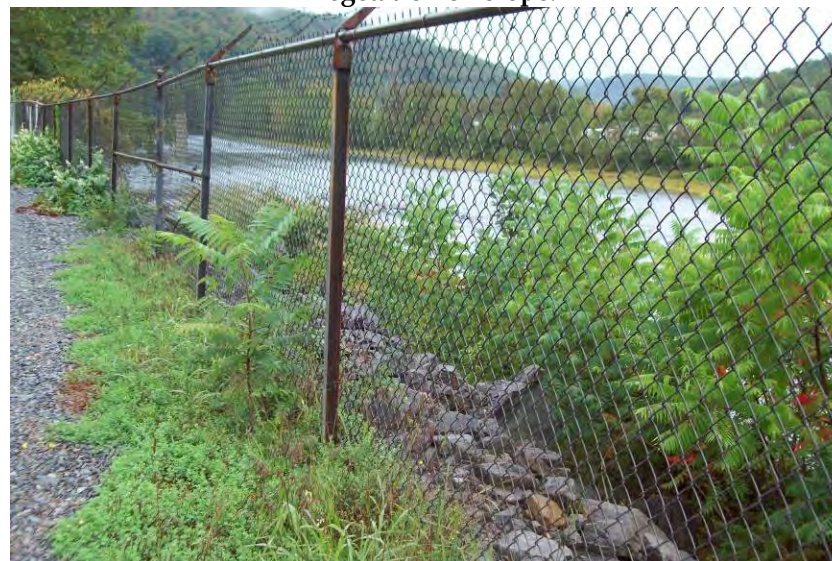
Photo 4: East embankment exterior slope, looking northwest. Note Cheat River in distance.

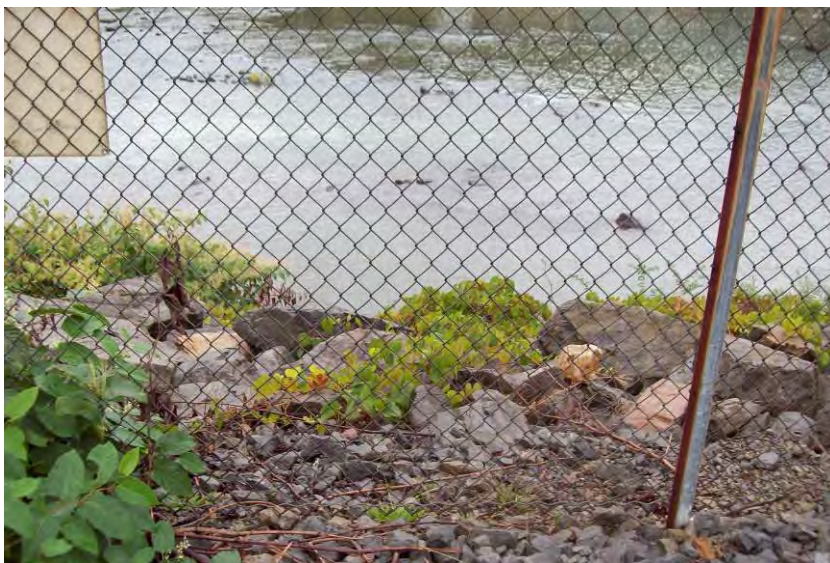
Photo 5: East embankment exterior slope, looking north. Note typical riprap and Cheat River in distance.

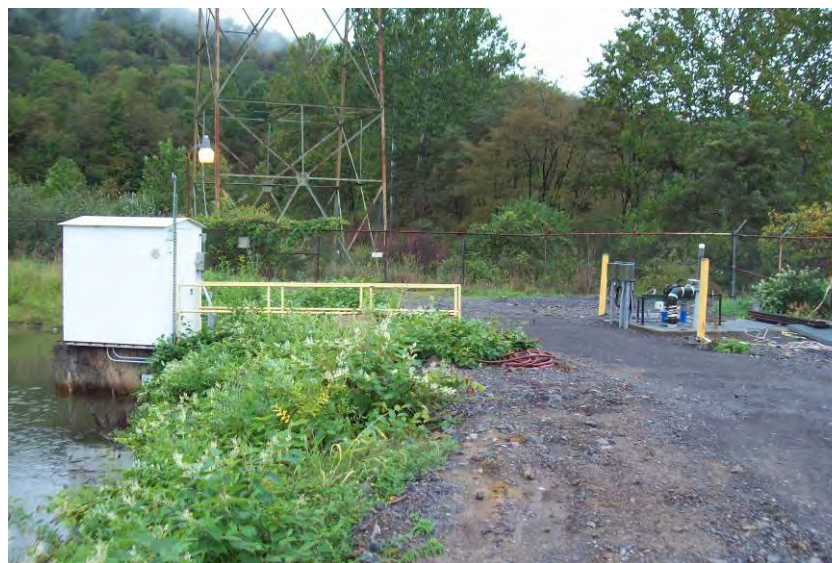
As designed and permitted; liquids from the impoundment are normally discharged through a pipeline to an on-site wastewater treatment system, and then to the Cheat River. The North Lagoon's outlet structure consists of a metal v-notched weir near the north embankment discharging to a 36-inch concrete pipe. The outlet structure also includes an opening with removable stoplogs used to control the weir's invert elevation (Photograph 13). The stoplogs were removed during the site assessment. The weir and pipe were submerged at the time of visual assessment. The 36-inch-diameter concrete pipe discharges into a sump structure (Photograph 6) that directs liquids to the on-

Photo 6: Sump structure at northeast corner of lagoon.

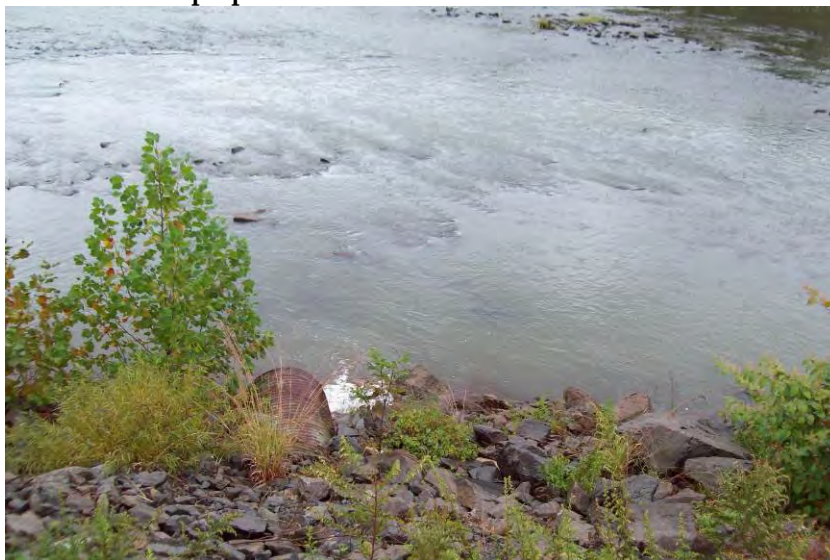
site wastewater treatment plant and then to the Cheat River. Discharge directly to the Cheat River, via 36-inch-diameter concrete pipe, is limited to emergency bypasses for flows in excess of the 25-year, 24-hour storm event. The 36-inch-diameter concrete pipe has a 36-inch-diameter corrugated metal pipe extension at the outfall (Photograph 7).

Photo 7: 36-inch-diameter pipe discharging liquid from North Process Wastewater Lagoon sump into Cheat River.

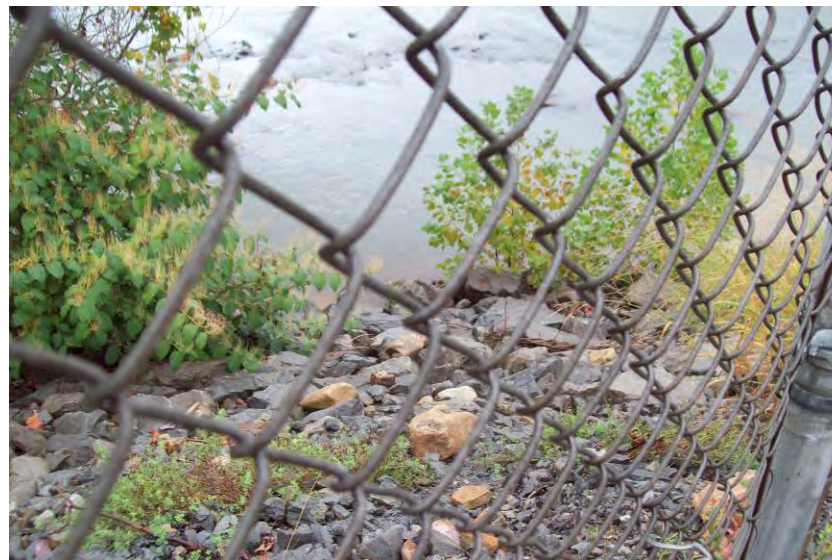
Photo 8: East embankment exterior slope near northeast corner. Note typical riprap and Cheat River in distance.

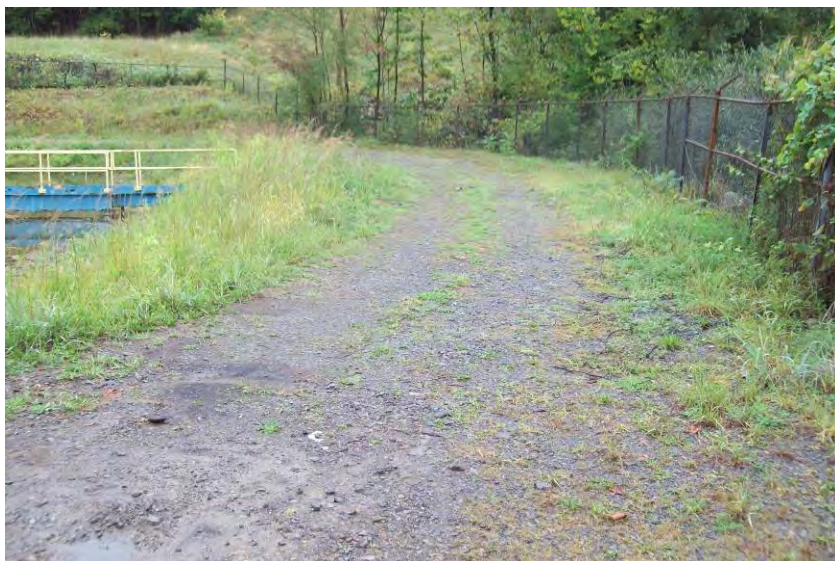
Photo 9: North embankment crest, looking southwest.

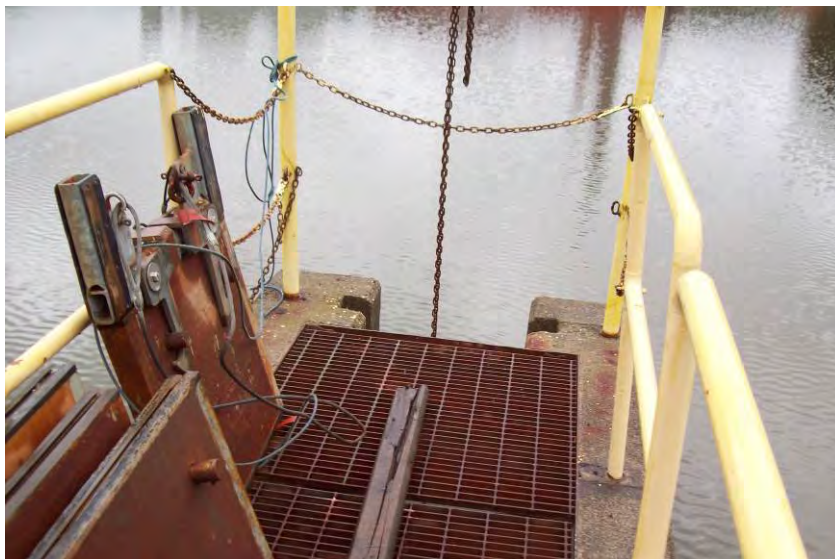
Photo 13: Outlet structure, removed stoplogs shown to the left.

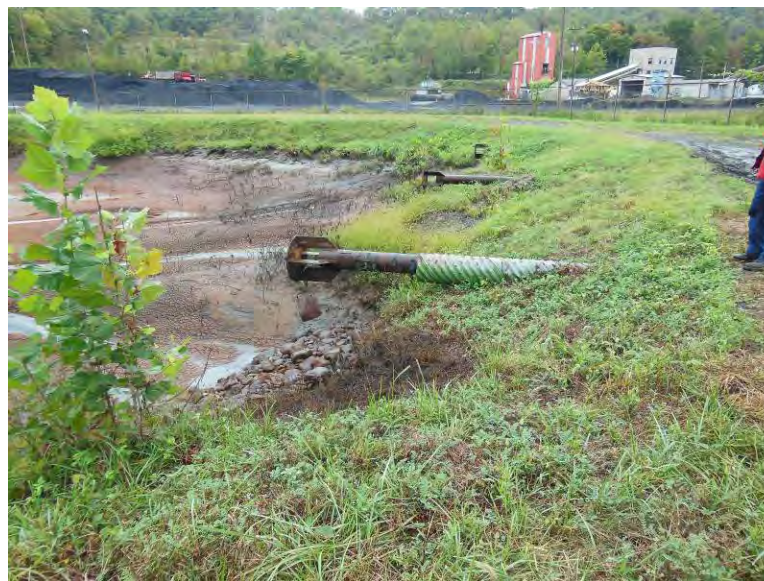
Interior slopes appeared to be in fair condition (Photographs 29, 33, 36, and 45). Areas of erosion were located just downstream at each of the three inlet pipes at the north embankment (Photograph 31) and at the inlet pipe at the west embankment (Photograph 34). Based on construction drawings, the interior slopes are 3H:1V at all embankments. Grassy vegetation covered the upper portion of the interior slopes.

Photo 29: North embankment interior slope, looking west. Note three 8-inch-diameter inlet pipes.

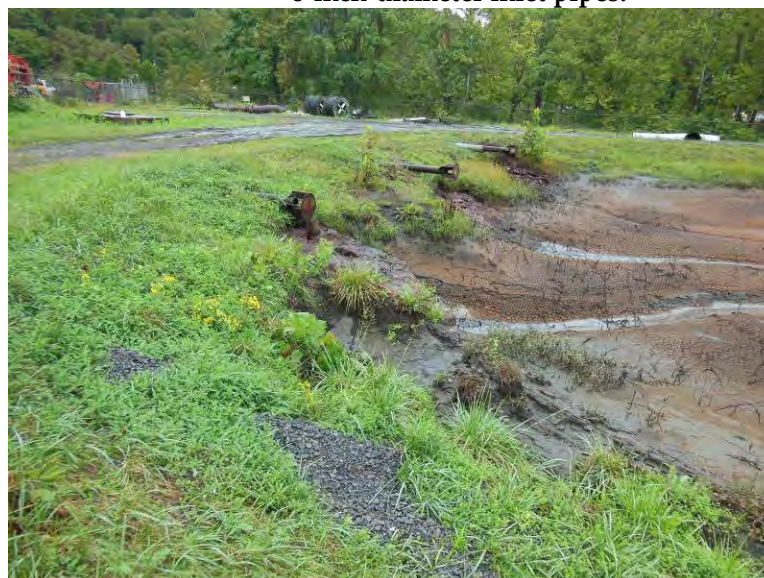
Photo 31: North embankment interior slope, looking east. Note areas of erosion at pipe discharge.

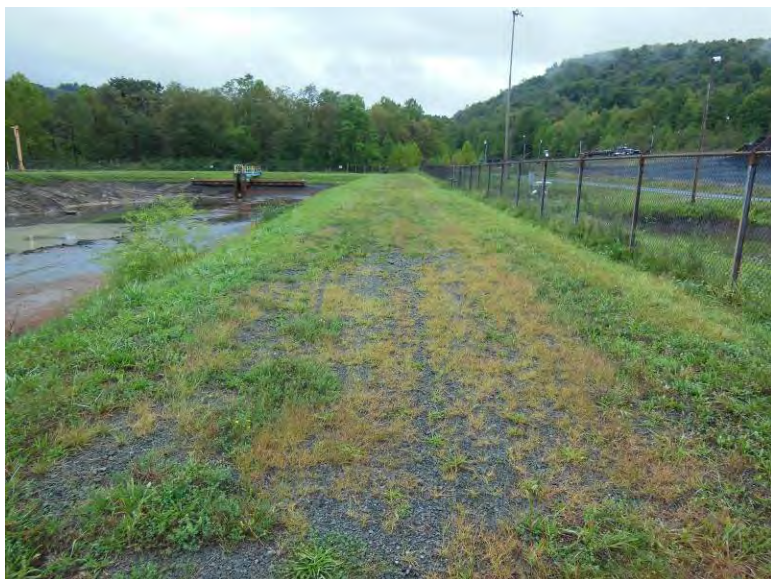
The north side of the South Lagoon is incised (Photograph 47). The south, east and west embankment crest appeared to be in satisfactory condition (Photographs 28, 32, 37 and 43). The crest width varied from 20 to 25 feet and consisted of compacted gravel and grass (Photographs 32, 37 and 43). The crest is exposed to minimal vehicle traffic. No depressions or evidence of settlement were observed.

Photo 32: West embankment crest, looking south.

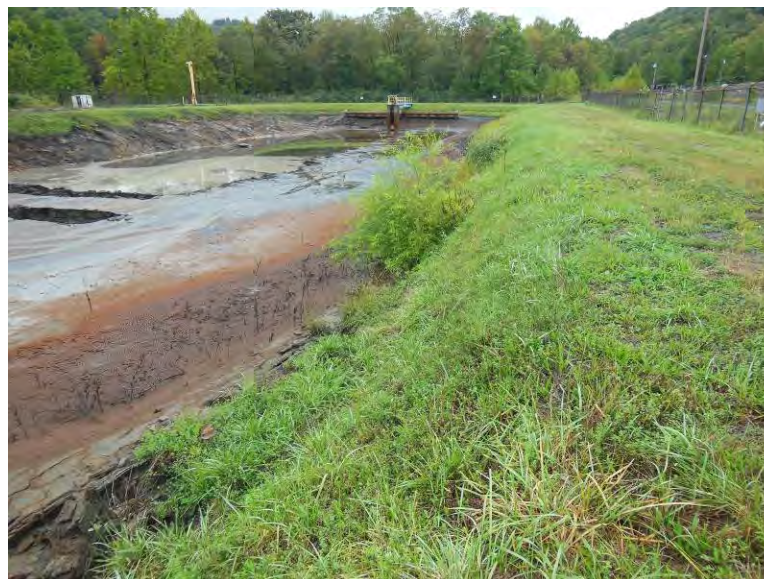
Photo 33: West embankment interior slope, looking south.

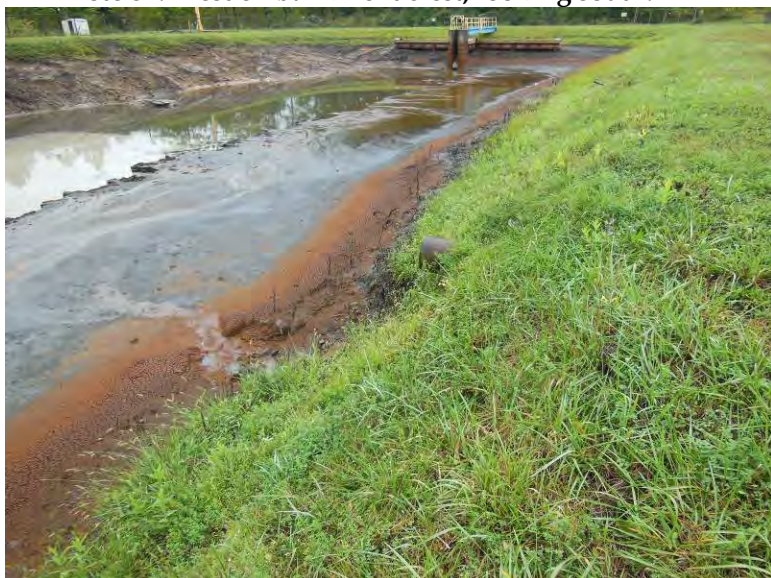
Three 8-inch-diameter inlet pipes are located at the interior slope of the north embankment (Photograph 30). One 18-inch-diameter inlet pipe is located at the interior slope of the west embankment (Photograph 34).

Photo 34: West embankment interior slope, looking south. Note 10-inch-diameter inlet pipe from coal pile runoff.

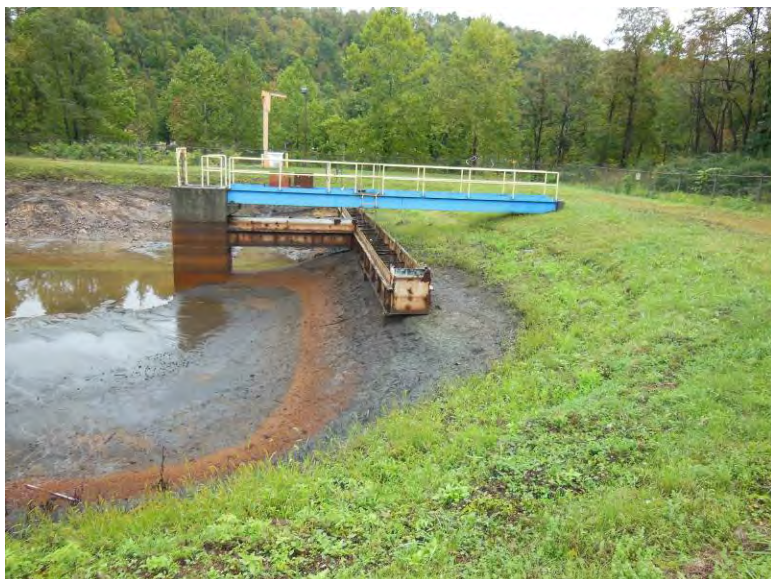
The outlet structure consists of a metal v-notched weir near the north embankment discharging to a 24-inch-diameter concrete pipe (Photographs 36, 39, 40 and 42). The outlet structure also includes an opening with removable stoplogs used to control the weir's invert elevation (Photograph 41). The stoplogs were removed during the site assessment. The 24-inch-diameter concrete pipe discharges into a sump structure (Photograph 58) that directs liquids to the on-site wastewater treatment plant, then to the Cheat River or an emergency bypass direct to the Cheat River may be implemented for flows in excess of the 25-year, 24-hour storm event (Photograph 60).

Photo 36: South embankment interior slope, looking east. Note outlet structure.

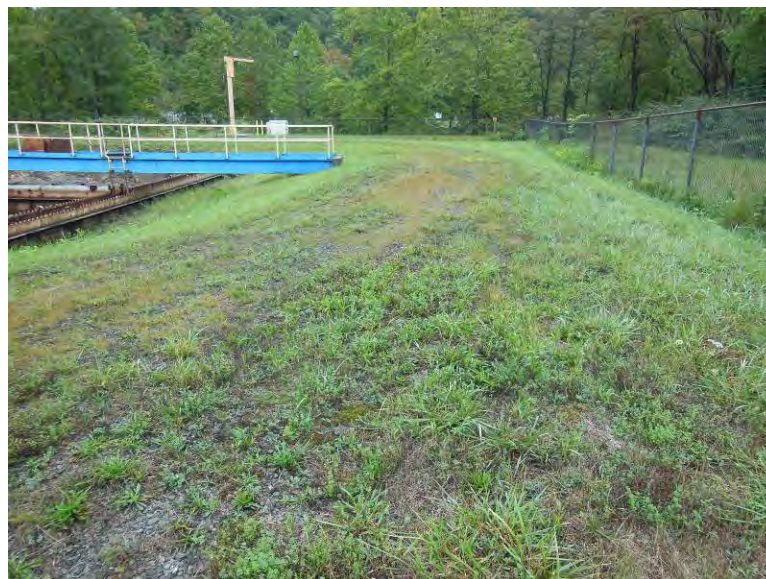
Photo 37: South embankment crest, looking east.

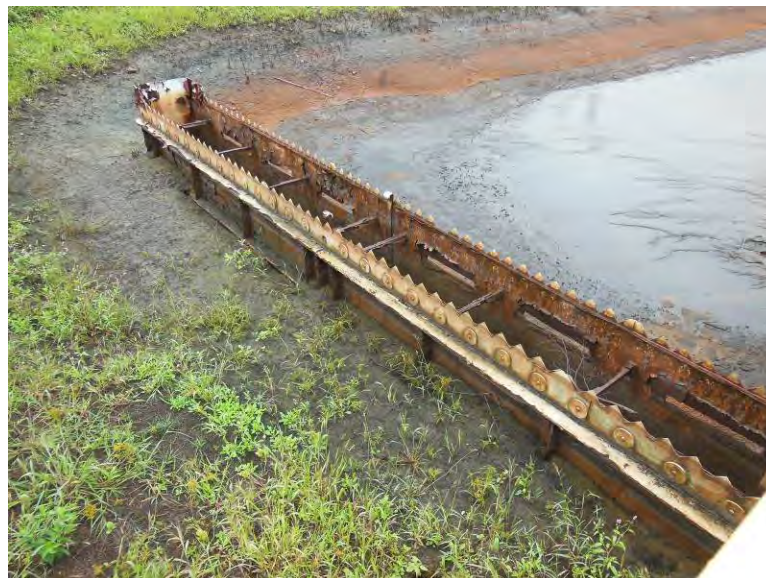
Photo 39: V-notch weirs at outlet structure.

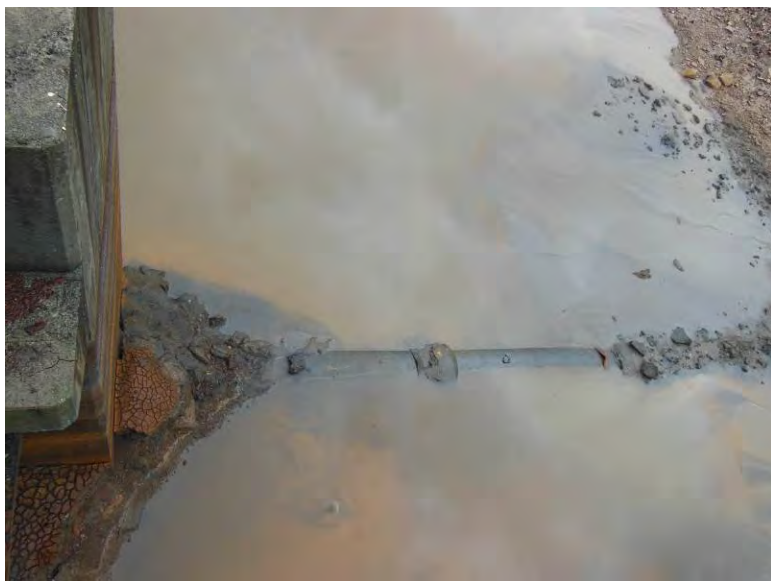
Photo 40: 24-in-dia pipe from outlet to sump.

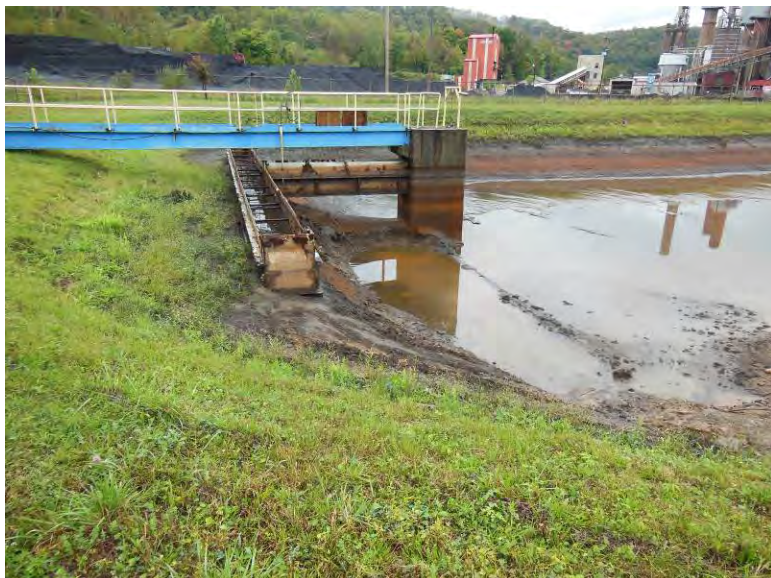
Photo 42: South embankment interior slope, looking west at outlet structure.

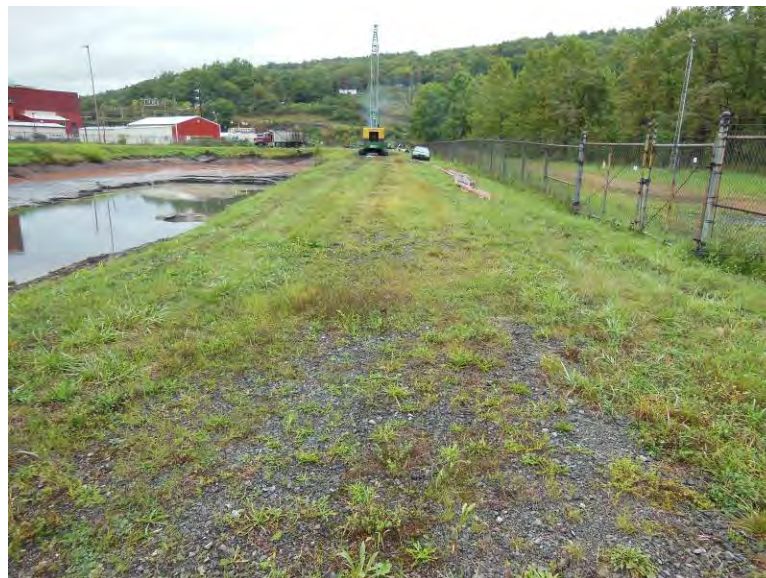
Photo 43: East embankment crest, looking north.

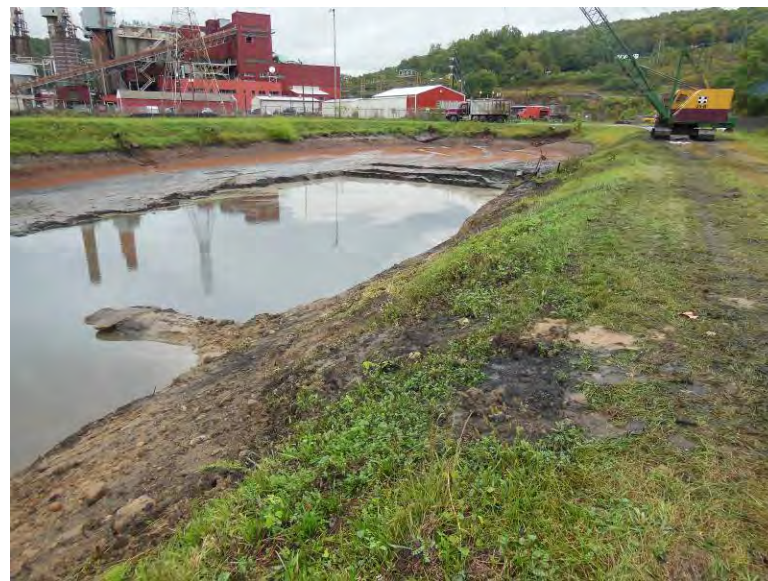
Photo 45: East embankment interior slope, looking north.

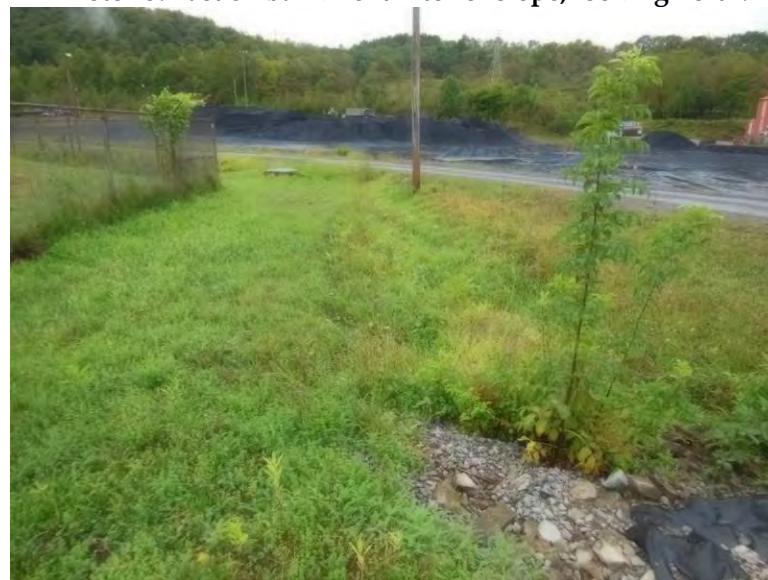
The lagoon includes exterior slopes on the west, east, and south embankments. The north side of the South Lagoon is incised (Photograph 47). The west embankment exterior slope is a coal pile runoff drainage and storage ditch that was nearly full during the site assessment (Photographs 49, 51, and 52). The exterior slopes of the south and east embankments are approximately 2H:1V. The exterior slopes of the south and east embankments are generally covered with grass, between 3 and 4 inches in height and appear to be in satisfactory condition (Photographs 37 and 43). The Cheat River is located approximately 100 feet east of the South Lagoon (Photographs 56 and 62).

Photo 47: North embankment exterior slope, looking west.

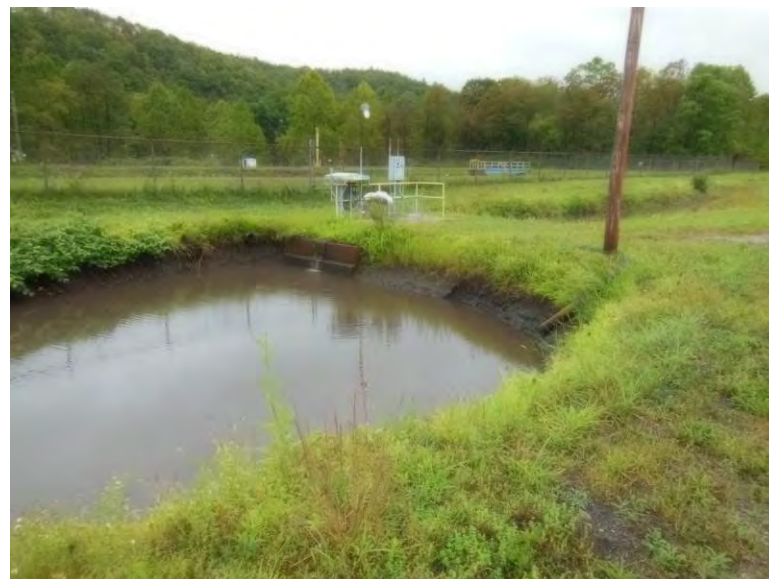
Photo 49: Coal pile runoff pond just west of the west embankment, looking southeast.

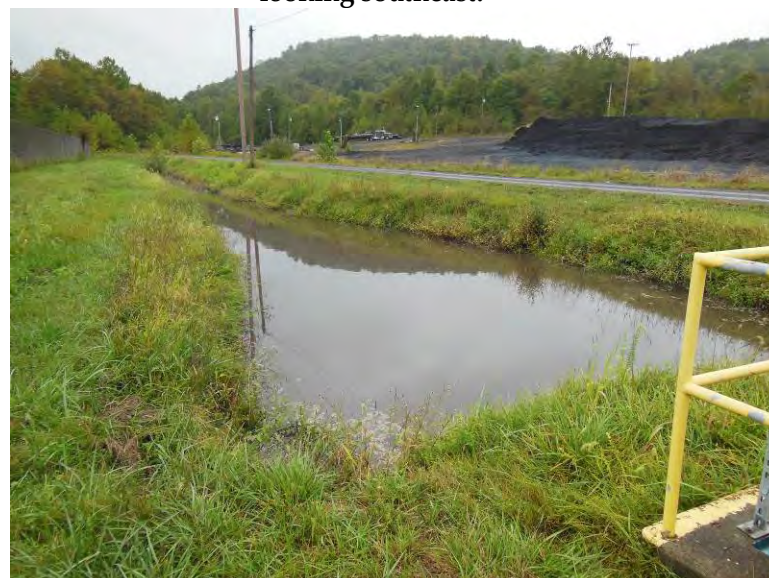
Photo 51: Coal pile runoff pond just west of the west embankment, looking south.

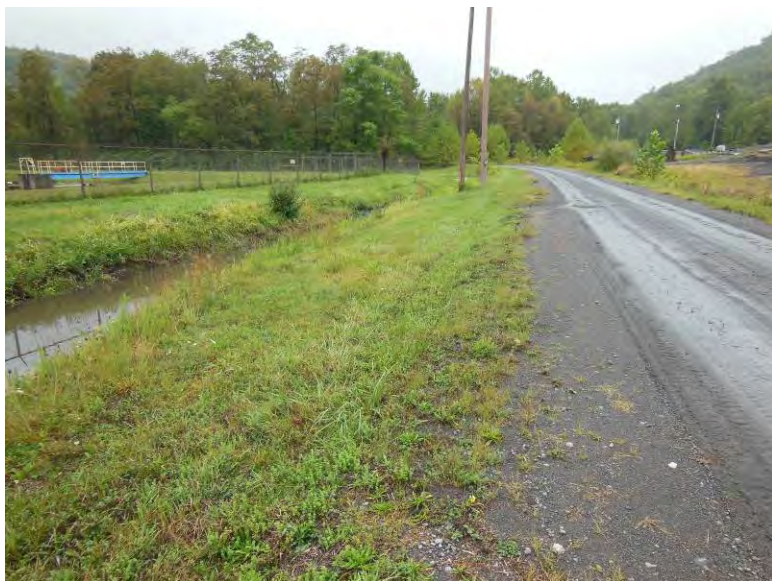
Photo 52: West embankment exterior slope looking south. Note coal pile runoff pond to the left.

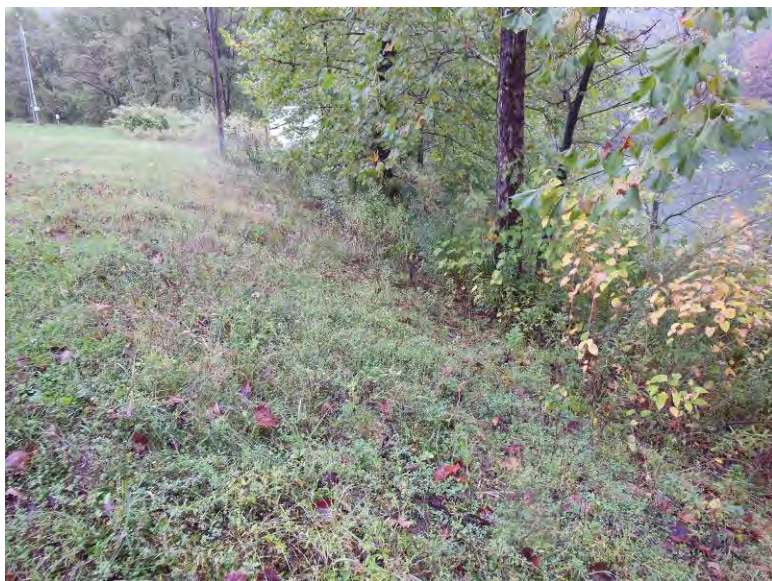
Photo 56: View beyond East embankment at southeast corner, looking northeast. Note Cheat River in top right.

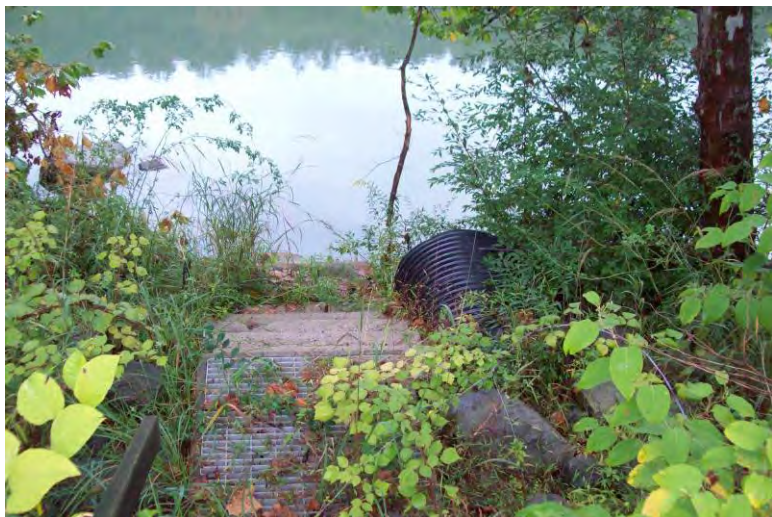
Photo 60: 36-in-dia outfall into Cheat River looking east.

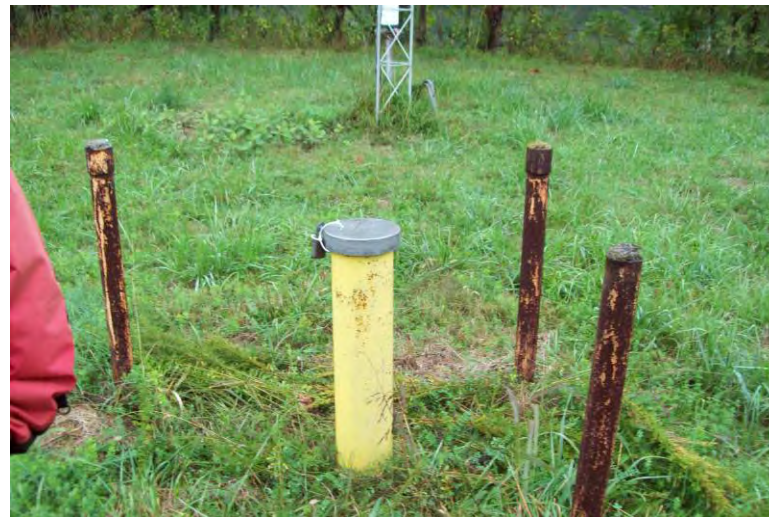
Photo 61: Monitoring well associated with coal pile storage, looking east.
